CERTIFIED BUILDING INSPECTORS

HOME INSPECTION REPORT

Front of home

**123 Sample St.
Orlando, FL 32888**

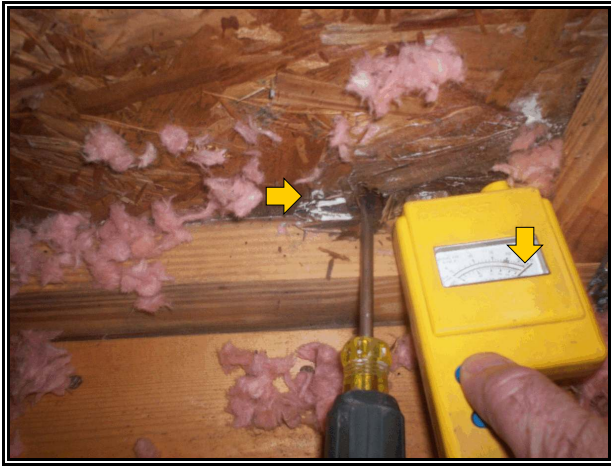
1. The damage by wood decay fungi as follows;
 - * sections at the base of the siding of the right gable end as seen in the attic, (See photos 1 and 2.)

2. Moisture intrusion into the home as evidenced by the moisture staining and increased moisture levels detected with a moisture meter at;
 - * the right side wall toward the rear of the front bedroom and behind the right wall of the hall bath shower where water is entering at the seam at the base of the right side gable end wall, (Again, see photos 1, 2 and 4.)

Photo 1- Wood decay and increased moisture at the base of the right gable end siding in the attic.

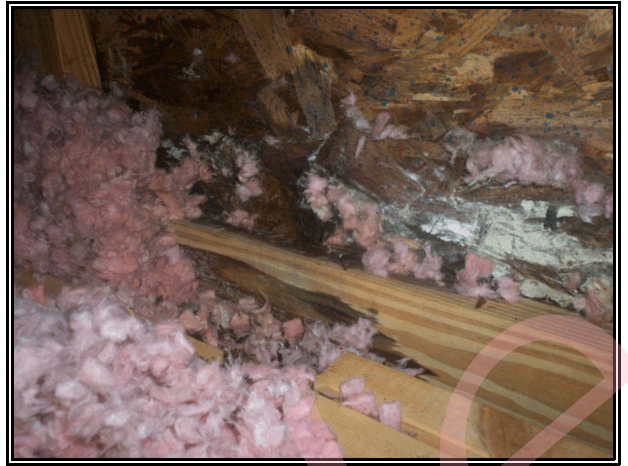
Photo 2- Another decayed section of the right gable end siding above the hall bath wall below.

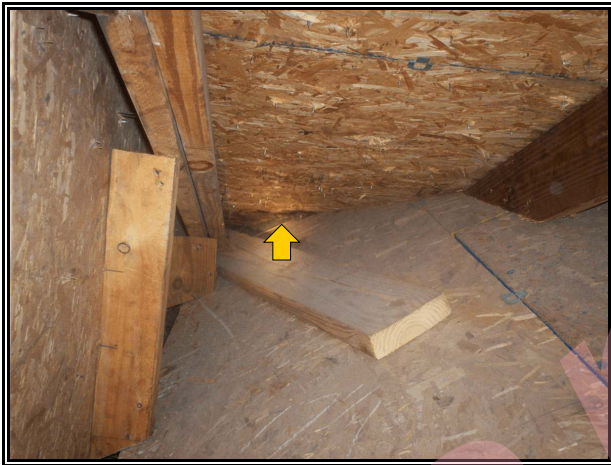
- * a section of the roof sheathing at the base of the valley to the right rear of the garage, (See photo 3.)
 - * the base of the jambs of the front entry door,

Photo 3- Wood decay at a section of roof sheathing below the base of the valley right of the garage.

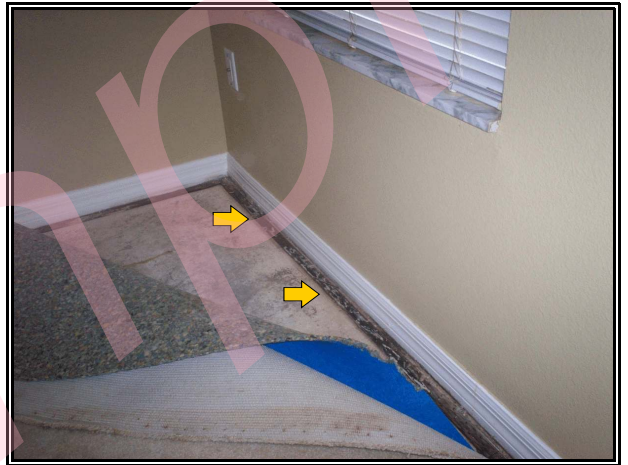
- * sections of the carpet tack strip at;
 - the base of the right wall of the right front bedroom below and to the rear of the window, (See photo 4.)
 - the base of the wall below the right jamb of the window assembly to the front of the living room. (See photo 5.)

Photo 4- Decay damaged section of the moist tack strip in the right front bedroom.

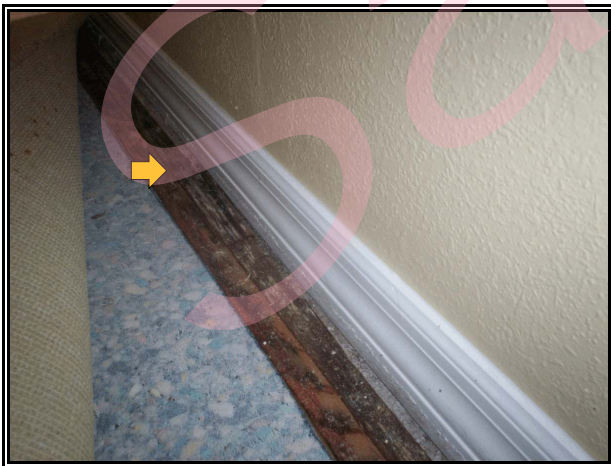
- * below the window at the front of the dining room, (See photo 6.)
 - * below the window at the front of the living room, (Again, see photo 5.)
 - * at the base of the right jamb of the rear sliding glass door assembly.
3. Pests entering the attic space at the displaced soffit segment at the right end of the eave to the right of the front door. (See photo 7.)
4. With the rain gutters;
 - * loose down spout segments at the left front corner of the house (see photo 8) and at the right side of the house,
 - * the right end of the run above the living room windows is disconnected and hanging down, (See photo 9.)

Photo 5- Decay damaged and slightly damp carpet tack strip at the front of the living room.

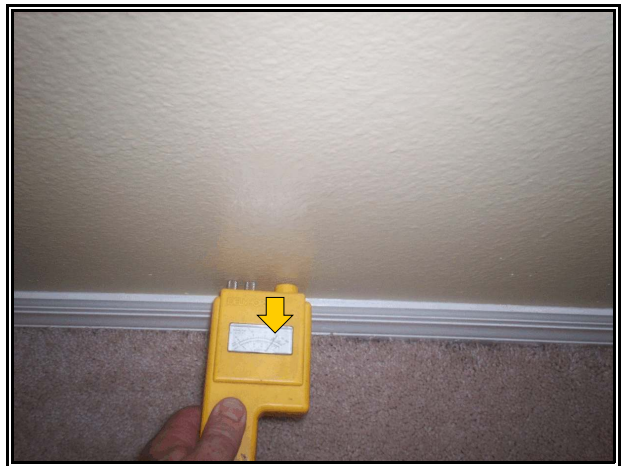
Photo 6- Increased moisture at the wall below the dining room window. The tack strip below is stained as well.

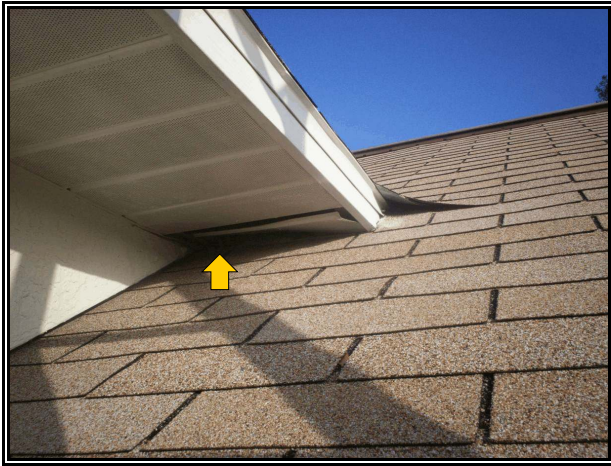
Photo 7- The displaced soffit cladding allow pest entry to the attic.

We did detect pest entry at the front of the attic at the displaced soffit segment identified in the Synopsis. This opening should be sealed to eliminate this access.

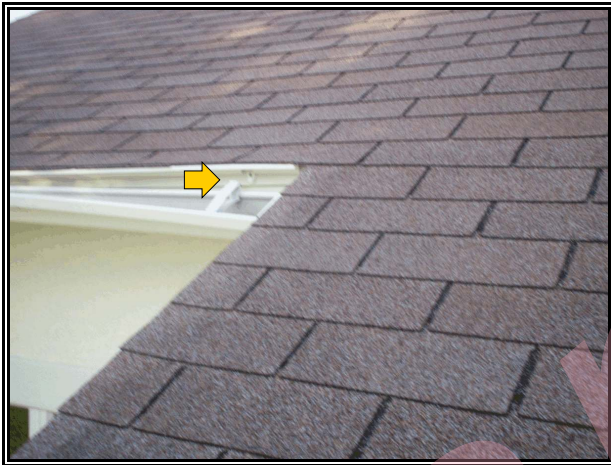
Photo 9- The disconnected run to the front of the living room.

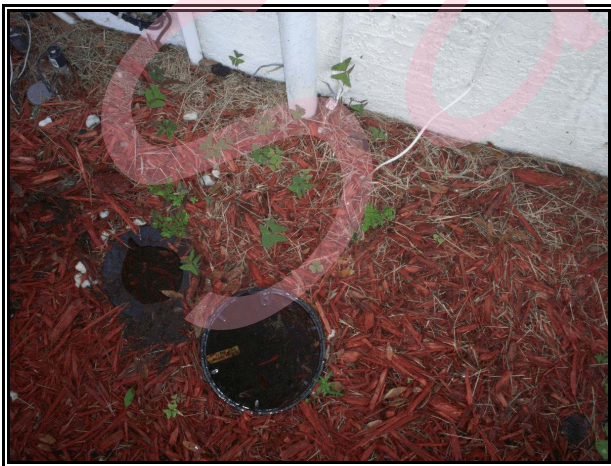
- * the missing drain stopper at the hall bath tub,
 - * the missing caps at the right side in ground wells for the domestic water and lawn sprinkler shut off valves. (See photo 11.)

Most of the fixtures have shut off valves below. The main shut off for the water supply is located at the right exterior of the home. The cover to the well housing it is missing as noted previously however. (Again, see photo 11.) This should be replaced.

Photo 11- The missing caps at the domestic and lawn sprinkler shut off valves right of the home.

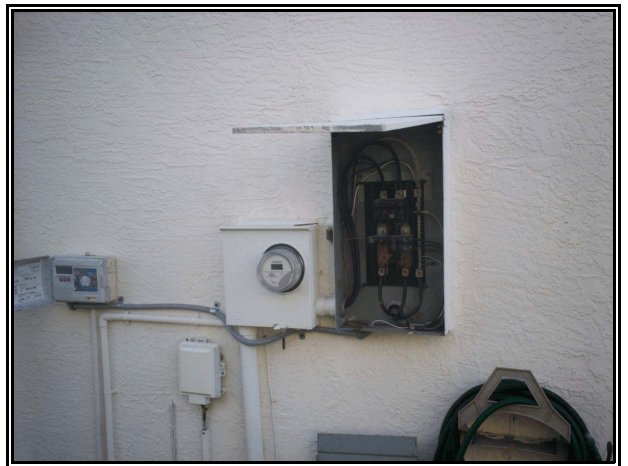
The main service into the home consisted of an underground, 120/240 volt feed, aluminum service entrance cables and a main disconnect rated at 150 amps. The disconnect was located adjacent to the meter on the right exterior wall of the house. (See photo 12.) The service was grounded on the exterior.

Photo 12- The main 150 amp disconnect panel and active lawn sprinkler panel right of the home.
