Home Inspection Report

**1064 Roy Avenue
San Jose, CA**

Inspection Date:
February 2, 2004

Prepared By:
**Gillespie Home
Inspection
5594 Bobbywood Ave.
San Jose, CA 95124**

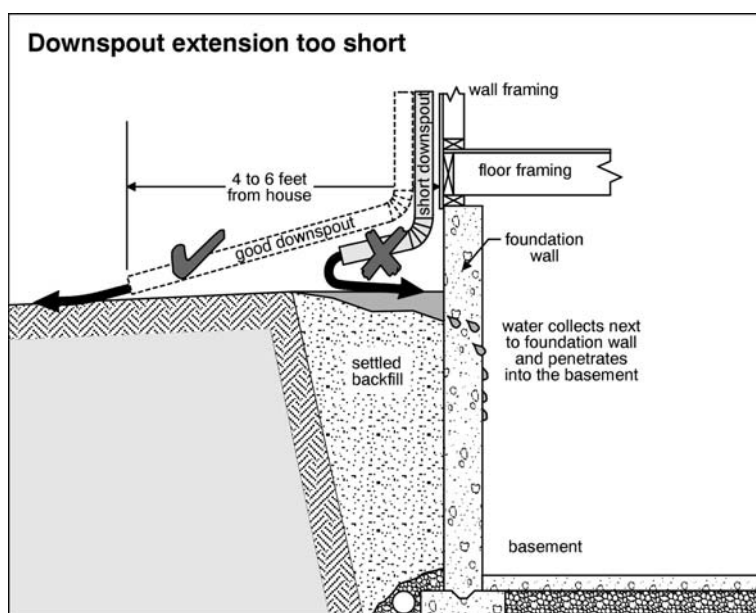
Several of the downspouts were not properly extended away from the building foundation. This condition will allow roof water to pool near the foundation, often leading to excess moisture around the foundation or in the basement and/or underbuilding crawl space. The discharge from all downspouts should be routed sufficiently away from the structure (usually at least 6' to 10') to prevent puddling, pooling, and saturation of the soil around the building.
